# Vääräkoski Board Mill – One Hundred Years of Cardboard from Ähtäri

REPORTS OF WEST FINLAND REGIONAL  
ENVIRONMENT CENTRE 3 en | 2008

This inventory report is published as part of the renovation project of Vääräkoski Board Mill (Vääräkosken kartonkitehdas). The joint project of the West Finland Regional Environment Centre and the Regional Council of South Ostrobothnia, entitled "Renovation of Vääräkoski Board Mill", was initiated on June 20, 2000, and completed on February 29, 2008. The industrial and architectural review was carried out originally as a report in 2002 and revised in 2005.

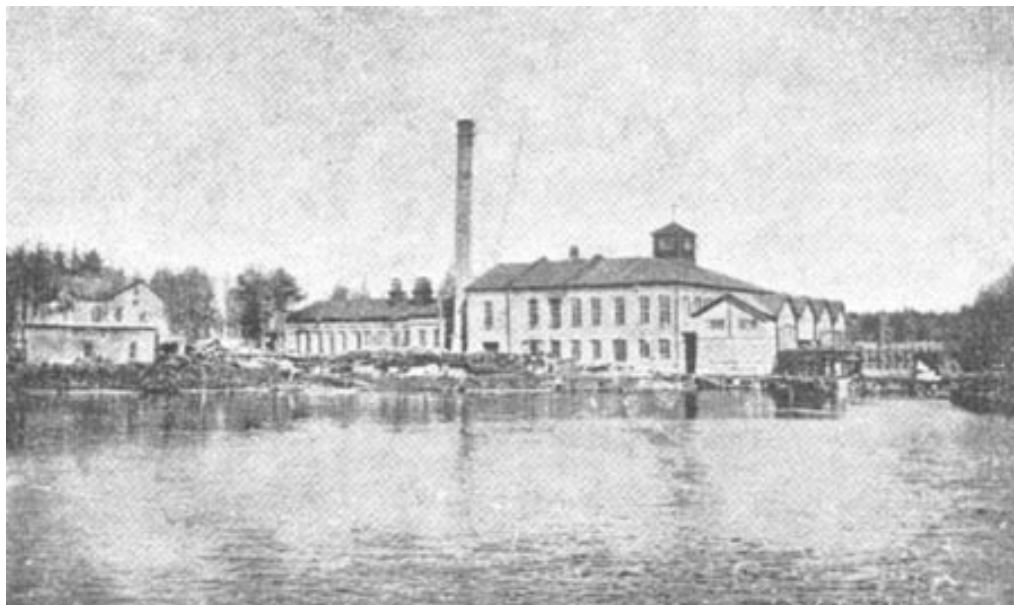
Illustration 1. Vääräkoski Board Mill in the early 1900s. Suomen teollisuus ja kauppa, 1928.

The cardboard mill stands, apparently, in its original form in the photo published in 1928 (Figure 1). The mill building consists of a one-storey factory hall, plus a two-storey wing. A log-frame turbine house stands on the eastern end of the mill building, and its elevation to the river has four saddleback-roofed frontispieces. A flèche with a quadrilateral pavilion roof topped with a flagpole, stood on the roof of the groundwood pulp mill. The timber flèche can no longer be seen in the painting by F. Hautala (1933), depicting the Vääräkoski mill (Illustration 13).<sup>71</sup>

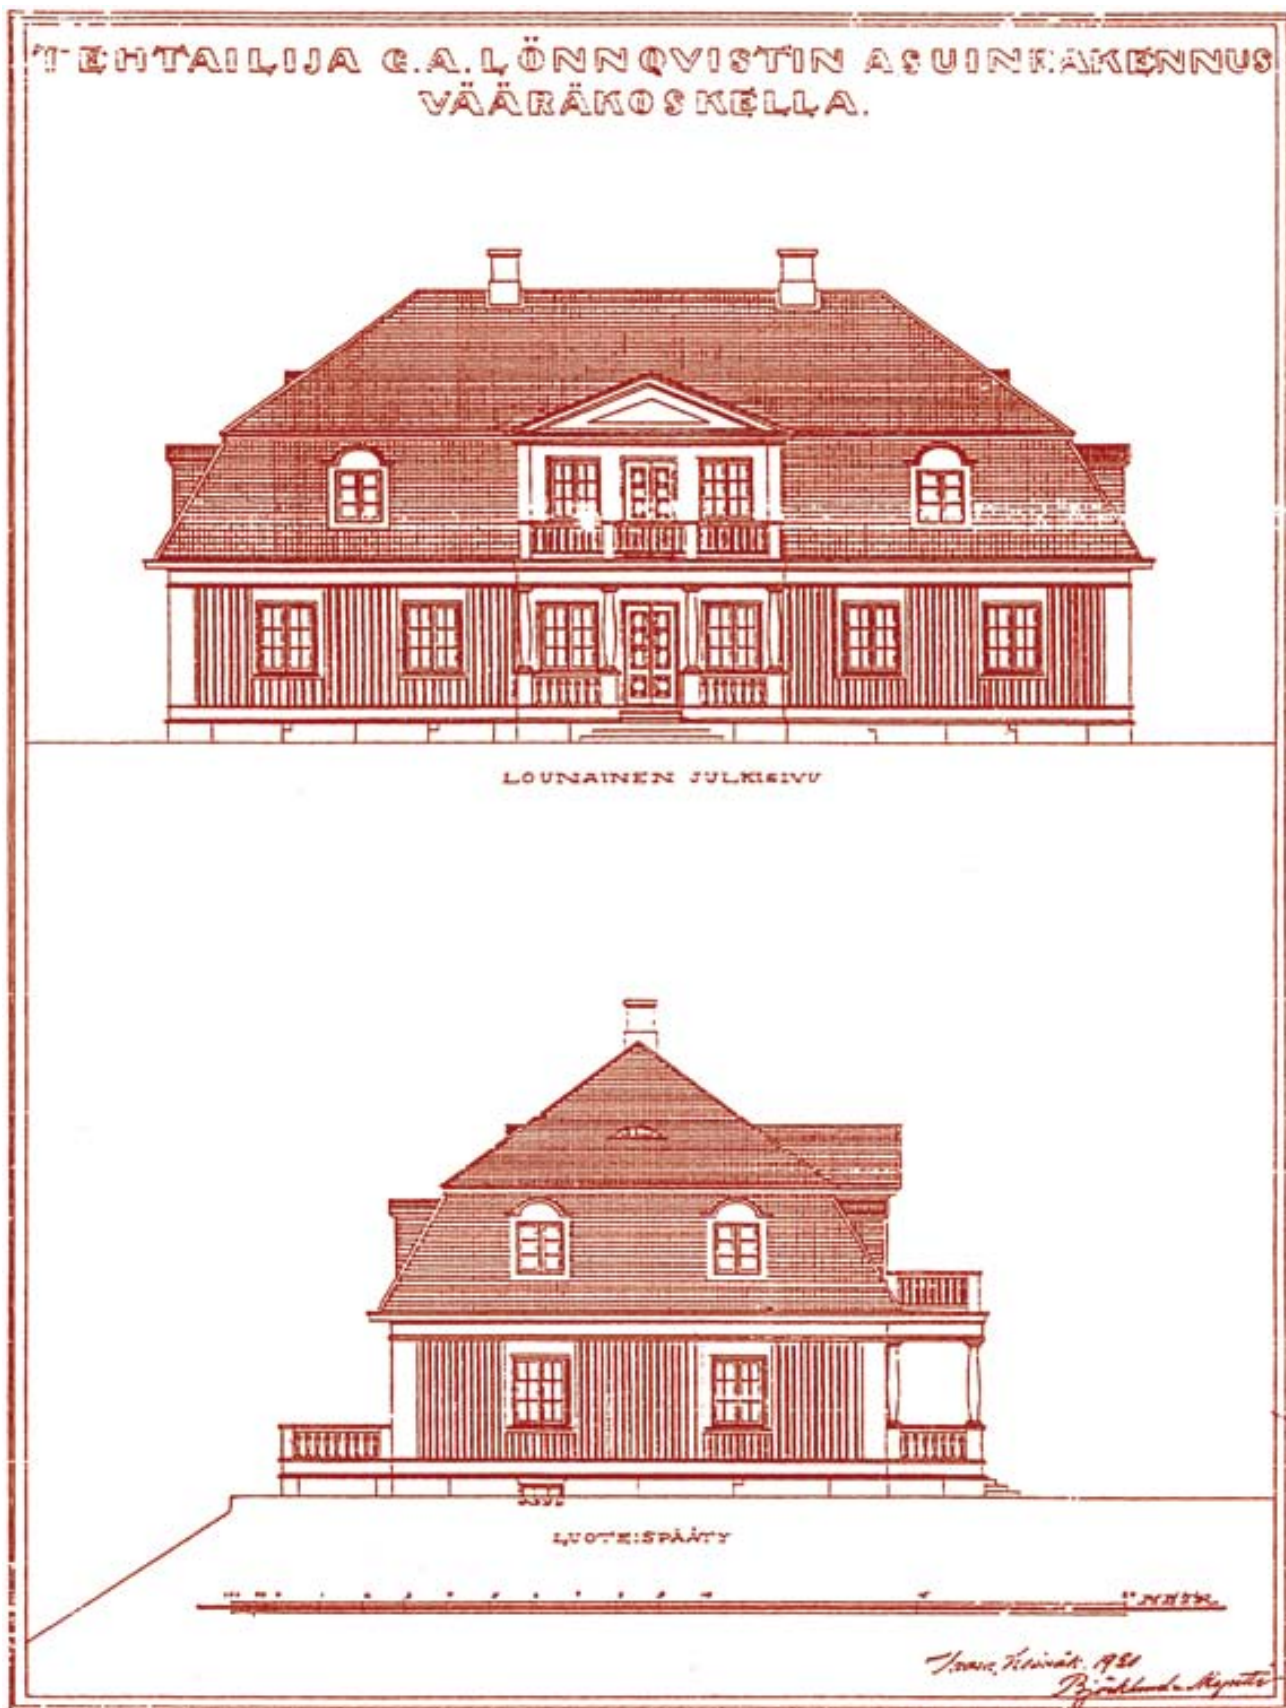
Illustration 7. Elevation drawings of the residence of manufacturer G.A. Lönnqvist from 1921. (Mäkelä, Riitta 1985: 21).

The director's residence is a wide-frame log building, which rests on an ashlar foundation. It has a mansard roof and frontispieces and moulded tympana under a saddleback roof on both sides. There are garret windows on each pane of the roof. Facing to the south-west, there is an open veranda with its pillars supporting the upstairs balcony. The building is clad in vertical shuttering and it has six-light windows. The roof material was replaced in 1978, the windows and boarding in 1993. The present owner has also refurbished the interior.

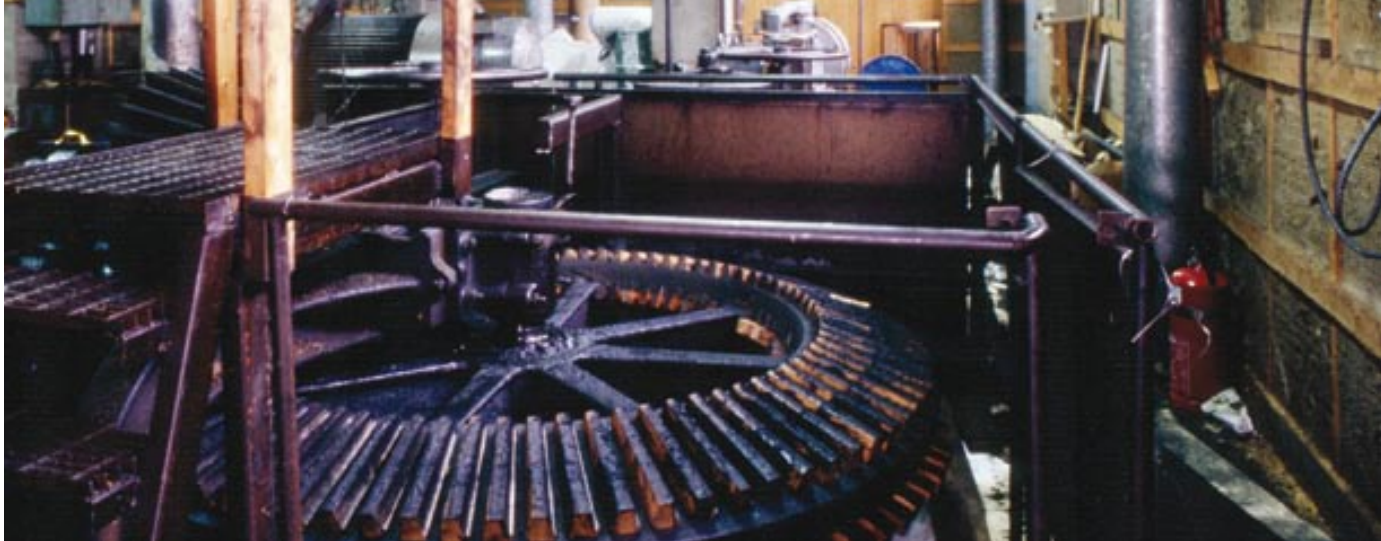
Illustration 9. The interior of the turbine room built in the 1980s. The wooden cogwheel of the water turbine is at the front. Matti Huuhka 1998, Museokuva, MV.

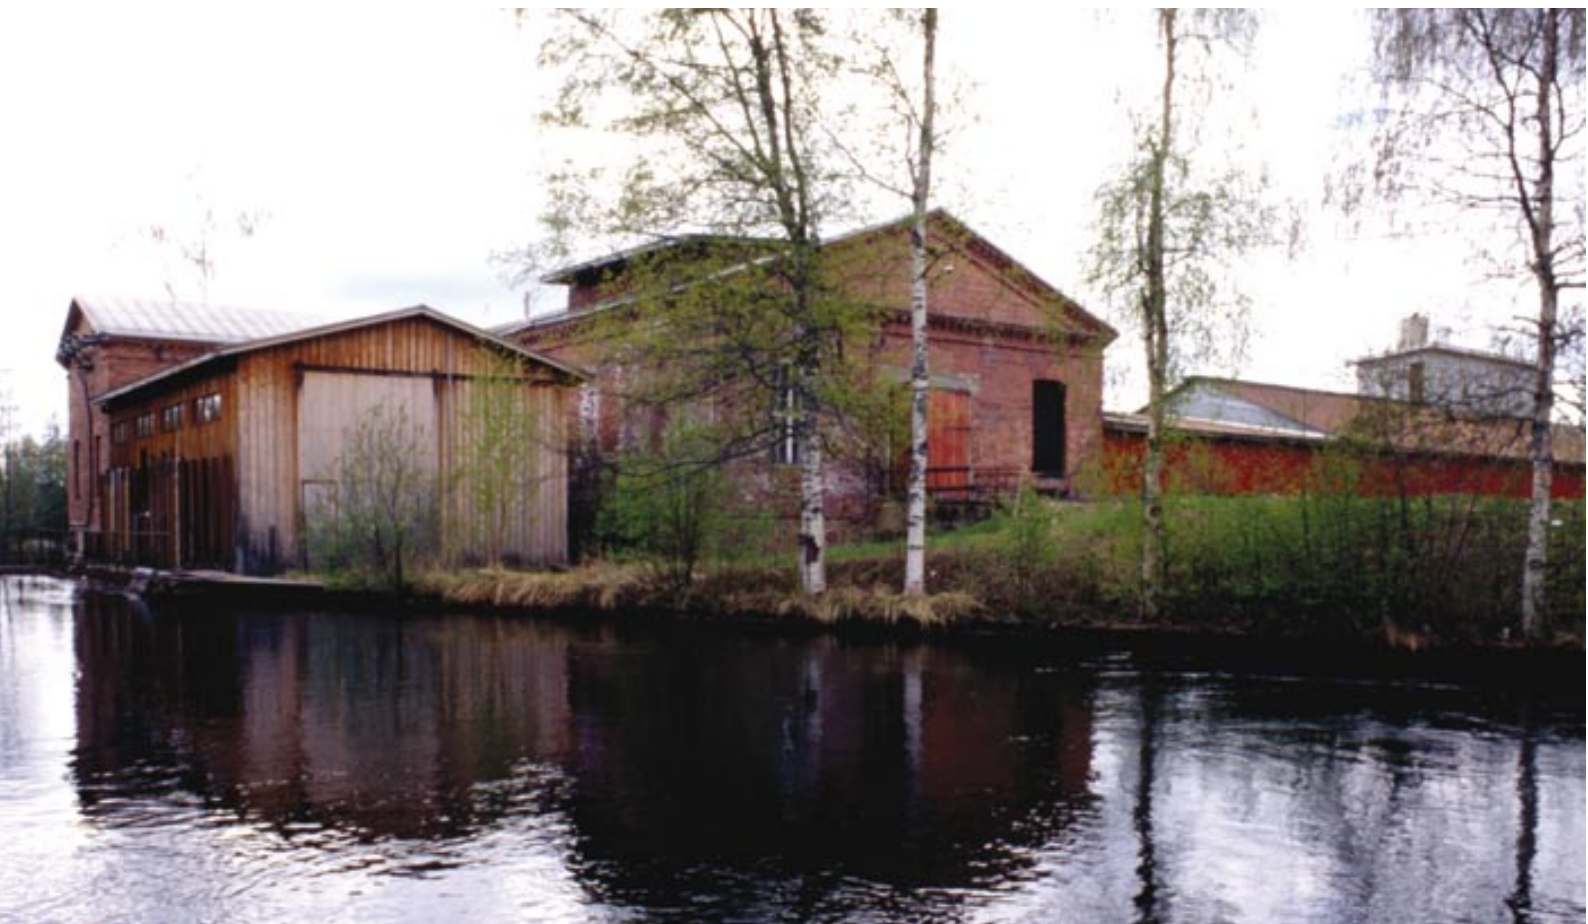
Illustration 10. The mill viewed from the dam. The turbine house, built in the 1980s, on the left. Behind it, the power plant. In the middle, the groundwood pulp mill, and on the right, the cardboard hall. Matti Huuhka 1998, Museokuva, MV.

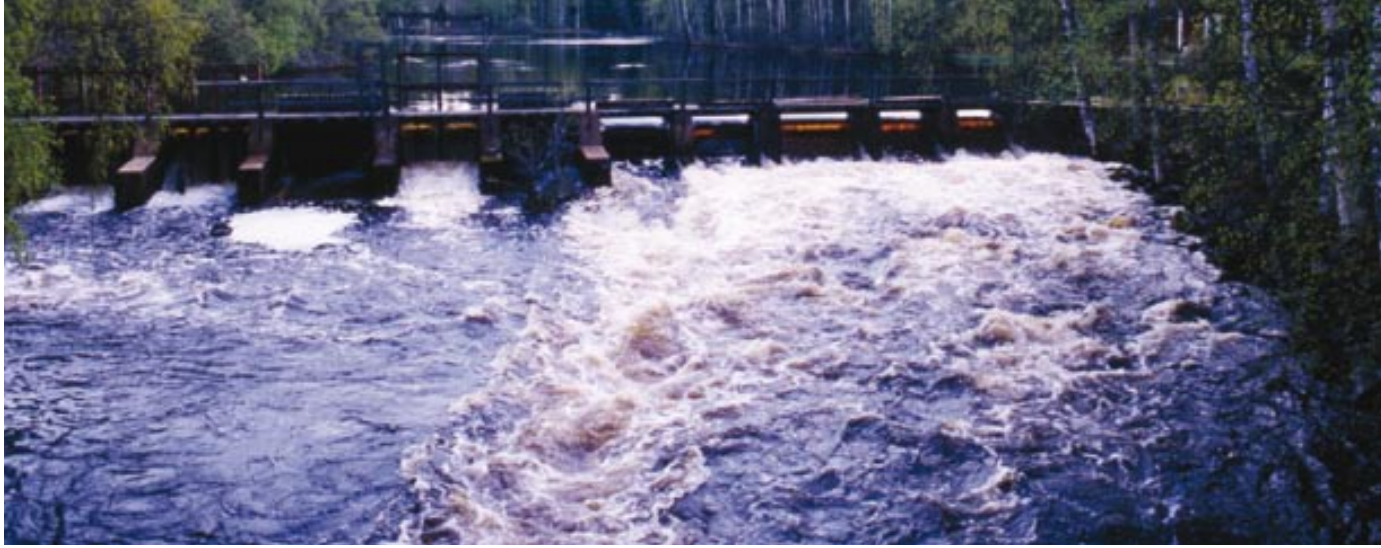
Illustration 11. The Perännekoski dam viewed from the south. Matti Huuhka 1998, Museokuva, MV.

The Perännekoski dam is located on the northern side of a small island, in the eastern branch of the river. According to inventory data, the channel of the lower mill and the other channel next to it were built in 1925, followed by its two dams in 1933 and 1940.<sup>63</sup> The Perännekoski dam is probably of later origin. The foundation of the dam and its supporting framework is made of concrete. The superstructures of all the dams have been renewed several times over the years. These repairs have often been confined to merely the replacement of rotted parts or lost floodgates. The wooden superstructure of the water channel, by the side of the lower mill, was last replaced in the late 1960s.<sup>64</sup>

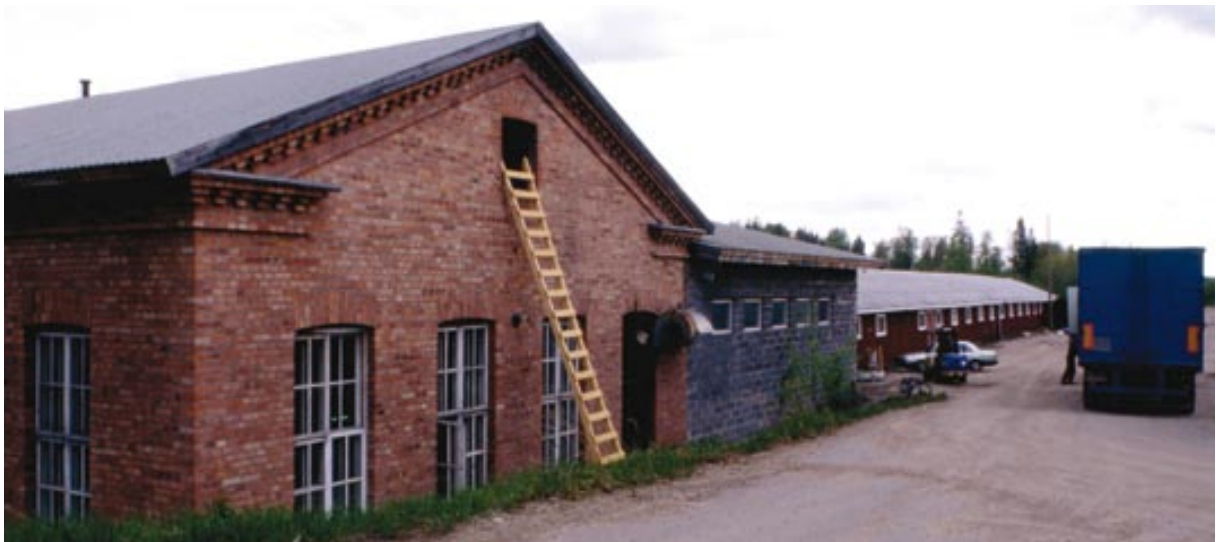
Illustration 14. The yard in the direction of the board mill. At the flank of the cardboard mill, the wing formed by the pulper hall and the storage hall. Matti Huuhka 1998, Museokuva, MV.

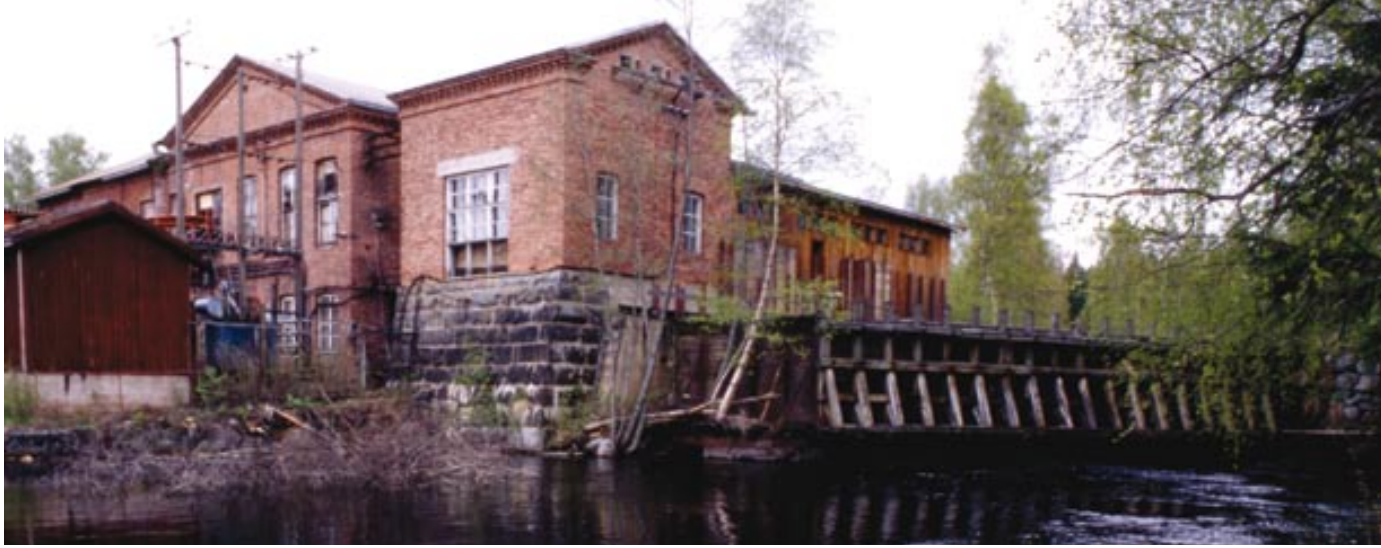
Illustration 16. Groundwood pulp mill, power plant, and turbine shed. The power plant channel on the right, and the transformer house on the left. Matti Huuhka 1998, Museokuva, MV.

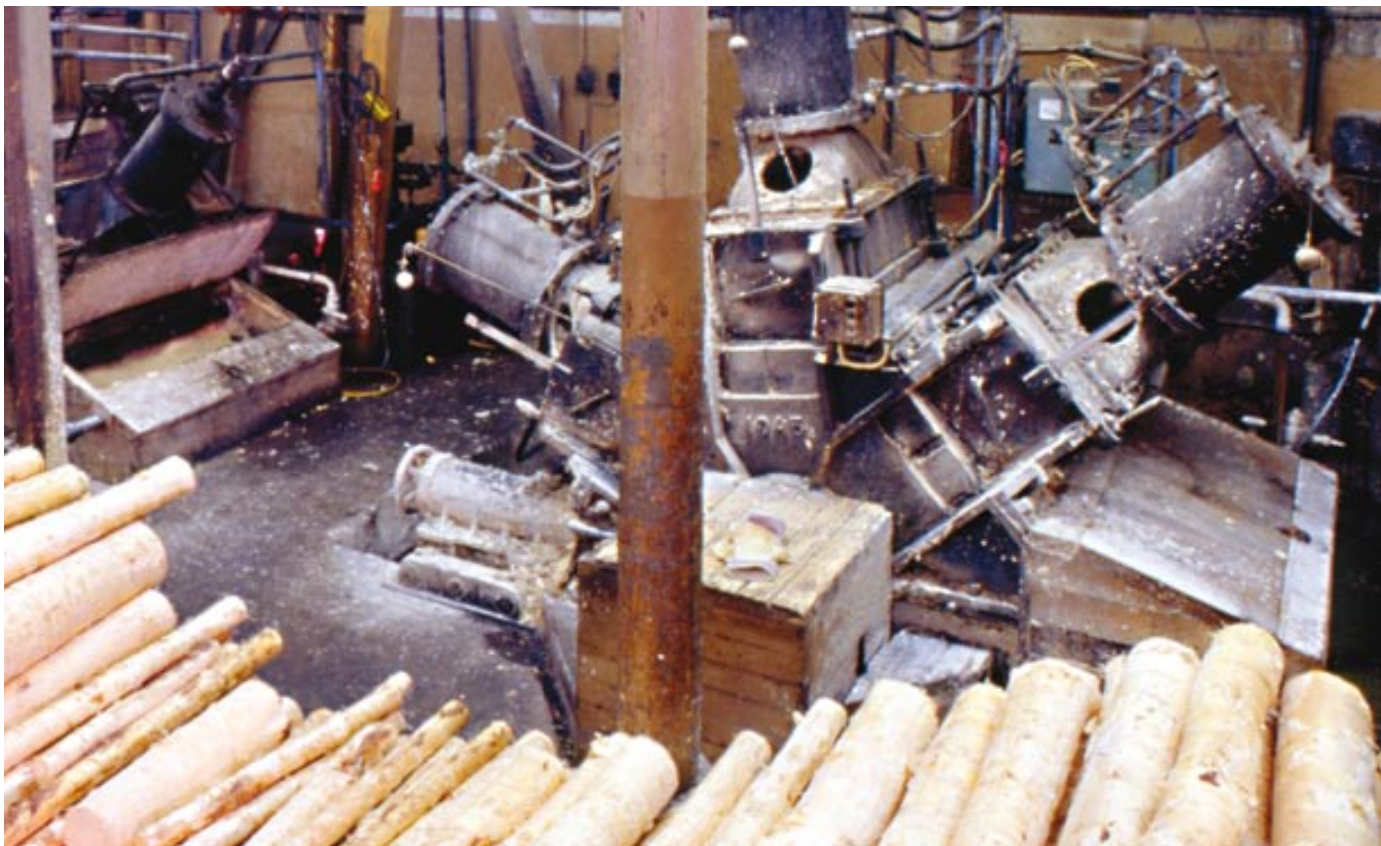
Illustration 17. Interior of the pulp mill. Matti Huuhka 1998, Museokuva, MV.

The pulp mill has a timber ceiling, supported by eight cast-iron columns filled with concrete. They replaced the previous one during the roof repair carried out in 1987. The support poles were originally made of wood. The north elevation has a high two-leafed door, and there is a wooden ramp outside for vehicles. There is a smaller two-leafed door in the eastern gable, as well as a doorway to the power plant building; however, it has been sealed later on.

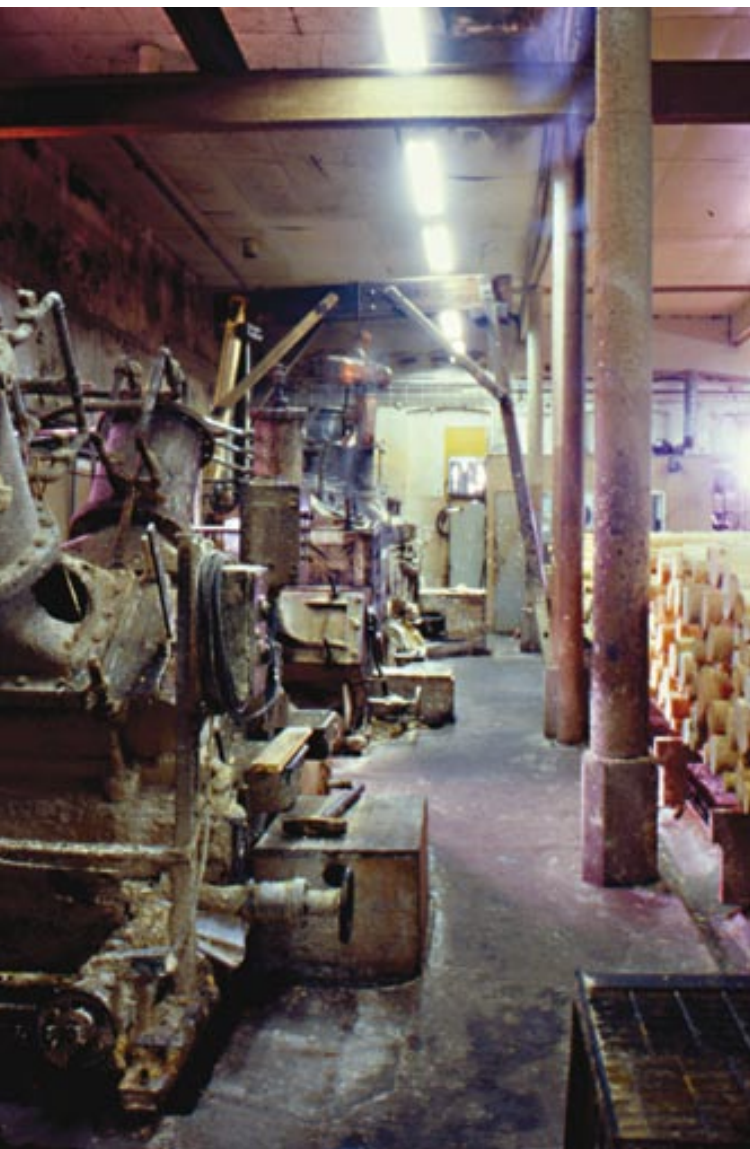
Illustration 18. Pulp-grinding machines viewed from the side. Spruce logs on the left. Behind the row of columns, at the back, is a light-structured restroom. Matti Huuhka 1998, Museokuva, MV.

Close to the pulp-grinding machines, there is a cast-iron pulley suspended on a wooden framework. The pulley was used to transport the heavy grinder stones. The last stones used in the pulp-grinding machines, were ceramic and made in Finland. They were replaced every 3-4 years. Previously, the machines had natural English grinder stones, which had to be replaced much more frequently.<sup>74</sup>

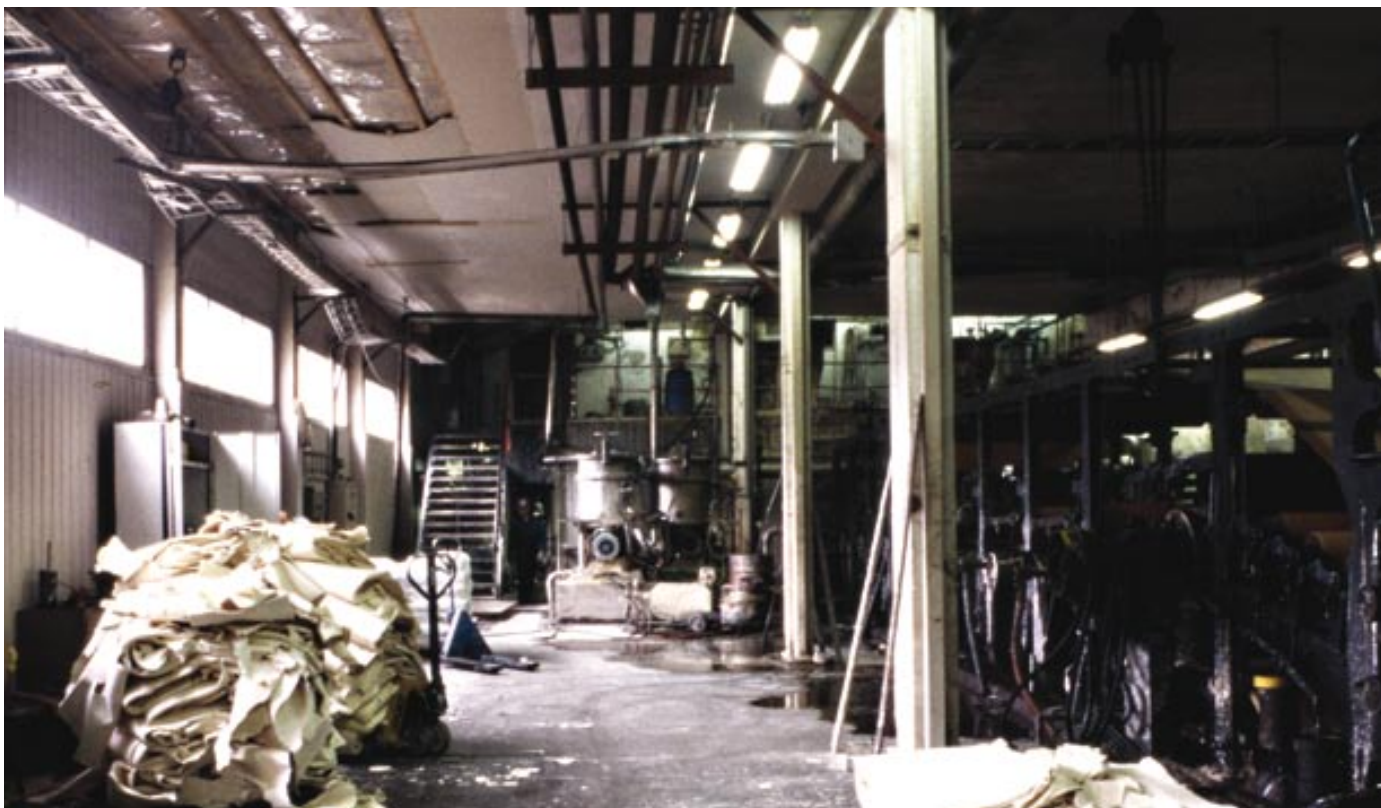
Illustration 20. A view from the back of the cardboard hall, at the wet end. The wooden stairs leading to the groundwood pulp mill and a vat in the background. Matti Huuhka 1998, Museokuva, MV.

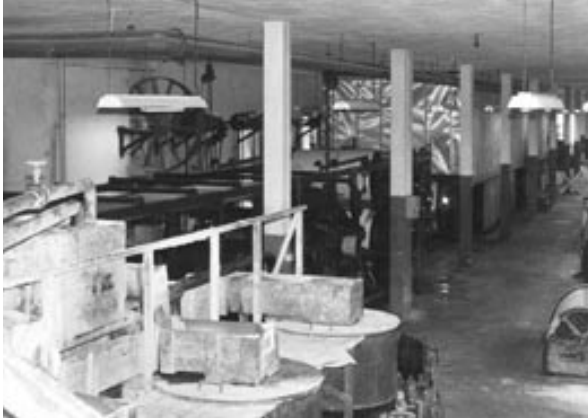
Illustration 21. The cardboard hall in the 1970s. Company archives.

In the cardboard hall, there is one of the oldest cardboard machines in Finland. It was manufactured by German H. Füllner Maschinenfabrik in Warnbrunn.<sup>77</sup> The wet end, where sheet board is formed out of wood pulp, remains from the original cardboard machine, whose effective width was 170 centimetres. The wet end was updated in 1935. The cardboard machine has seven control cylinders, thirteen drying cylinders, and two calenders.<sup>78</sup> The drying cylinders were replaced after the explosion in 1991.<sup>79</sup> The new cylinders were bought second-hand from Stockfors pulp-grinding mill in Pyhtää. The drying cylinders had originally been used at the Kaukaa paper mill to dry up wood cellulose.

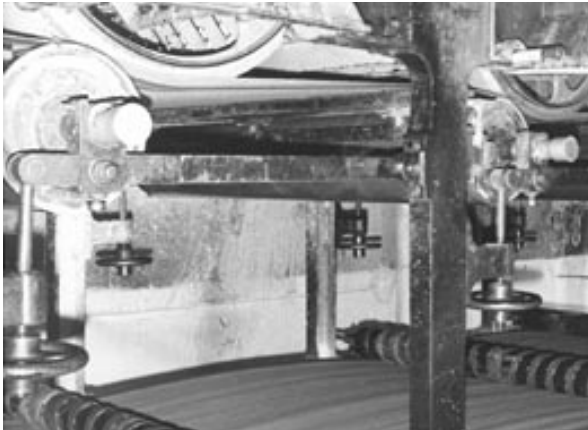
Illustration 22. The wet end of the cardboard machine in the 1970s. Company archives.

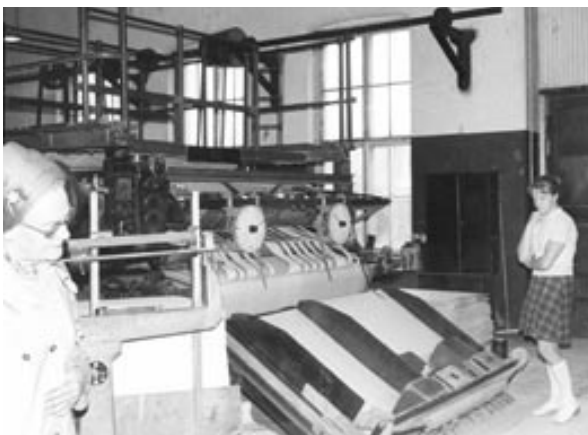
Illustration 23. The sheet cutter in the 1970s. Company archives.

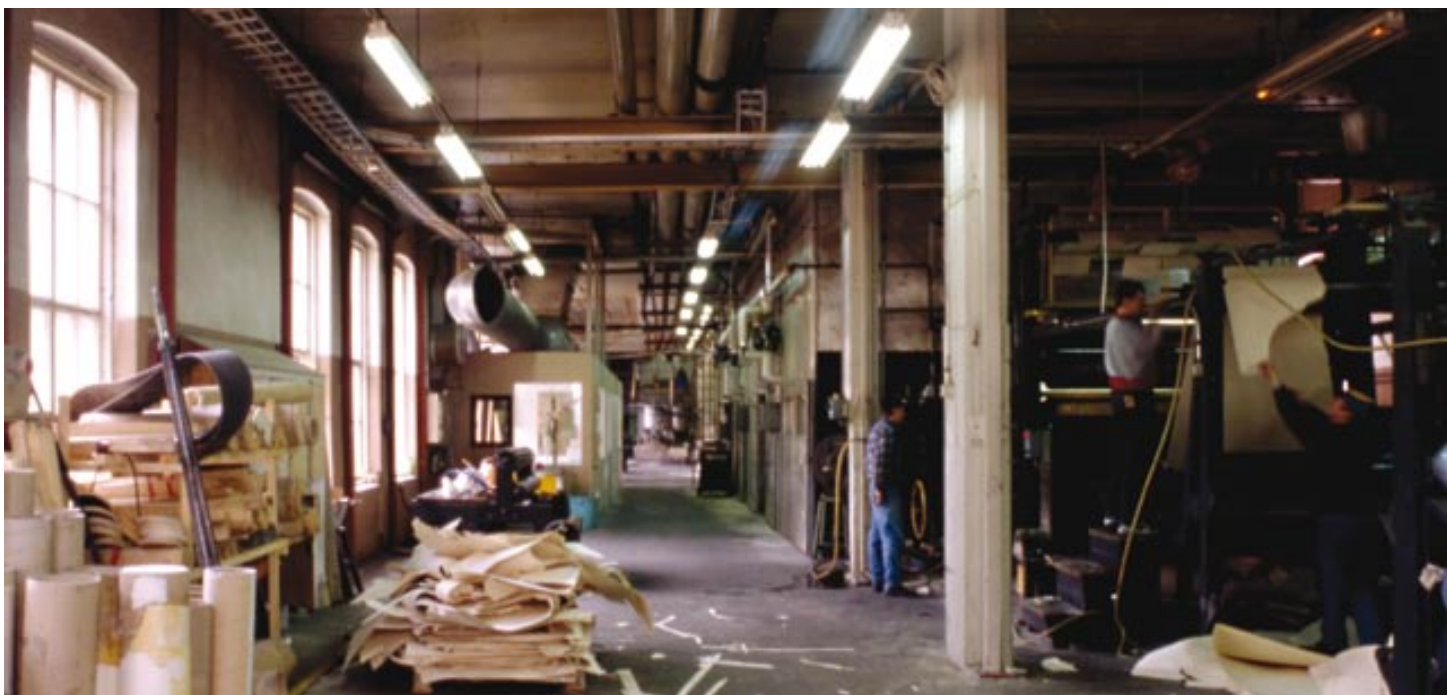
Illustration 24. A view from the front of the cardboard hall. Matti Huuhka 1998, Museokuva, MV.

Half way up the cardboard hall, by the drying cylinders, there is a steam hood. The purpose of this hood, consisting of a canopy and cut-off walls, is to retain the drying steam by the cylinders for as long as possible. The cut-off walls have narrow brackets and large sliding doors that can be moved along slide rails. The doors are covered with thin aluminium sheets.

There are concrete plate stands underneath the drying cylinders, and the edges that run along the cardboard machine are reinforced with railway rails. Tables, welded out of steel pipes, were added alongside the cardboard machine in the 1980s.

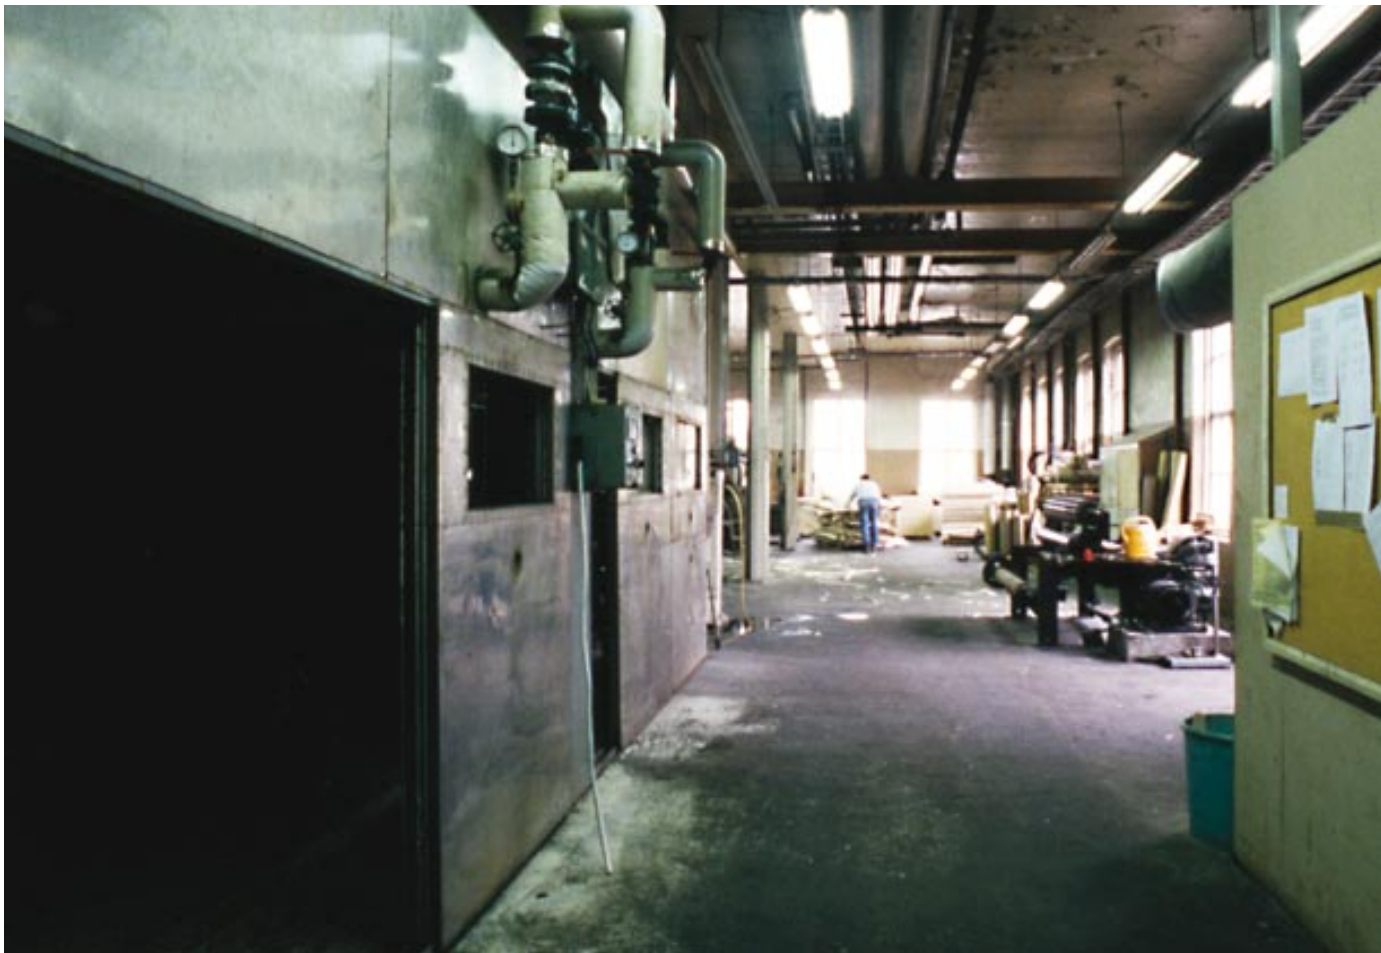
Illustration 25. Cardboard hall. On the left, the cut-off wall of the drying cylinders, covered with steel plates. On the right, a section of the restroom wall. Matti Huuhka 1998, Museokuva, MV.

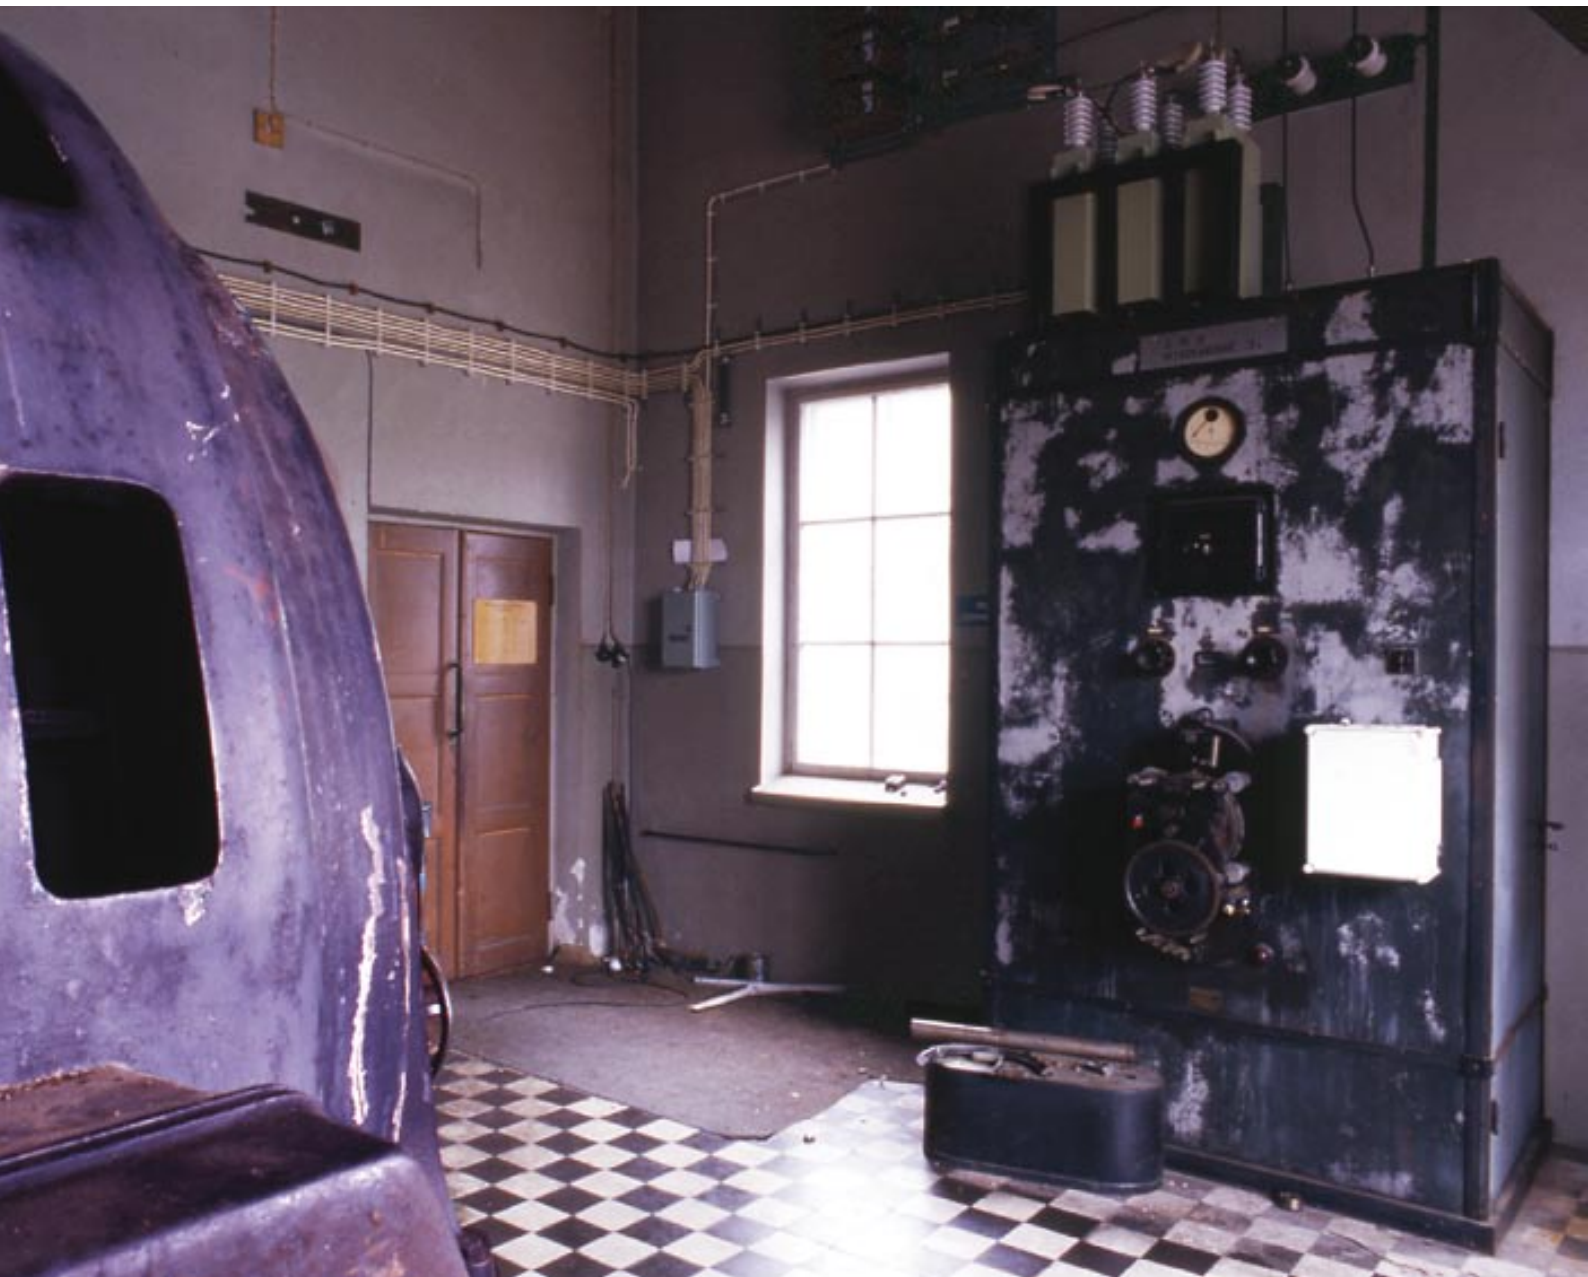
Illustration 28. The interior of the power plant. The three-phase synchronous motor and the tin control panel in the photo. Matti Huuhka 1998, Museokuva, MV.

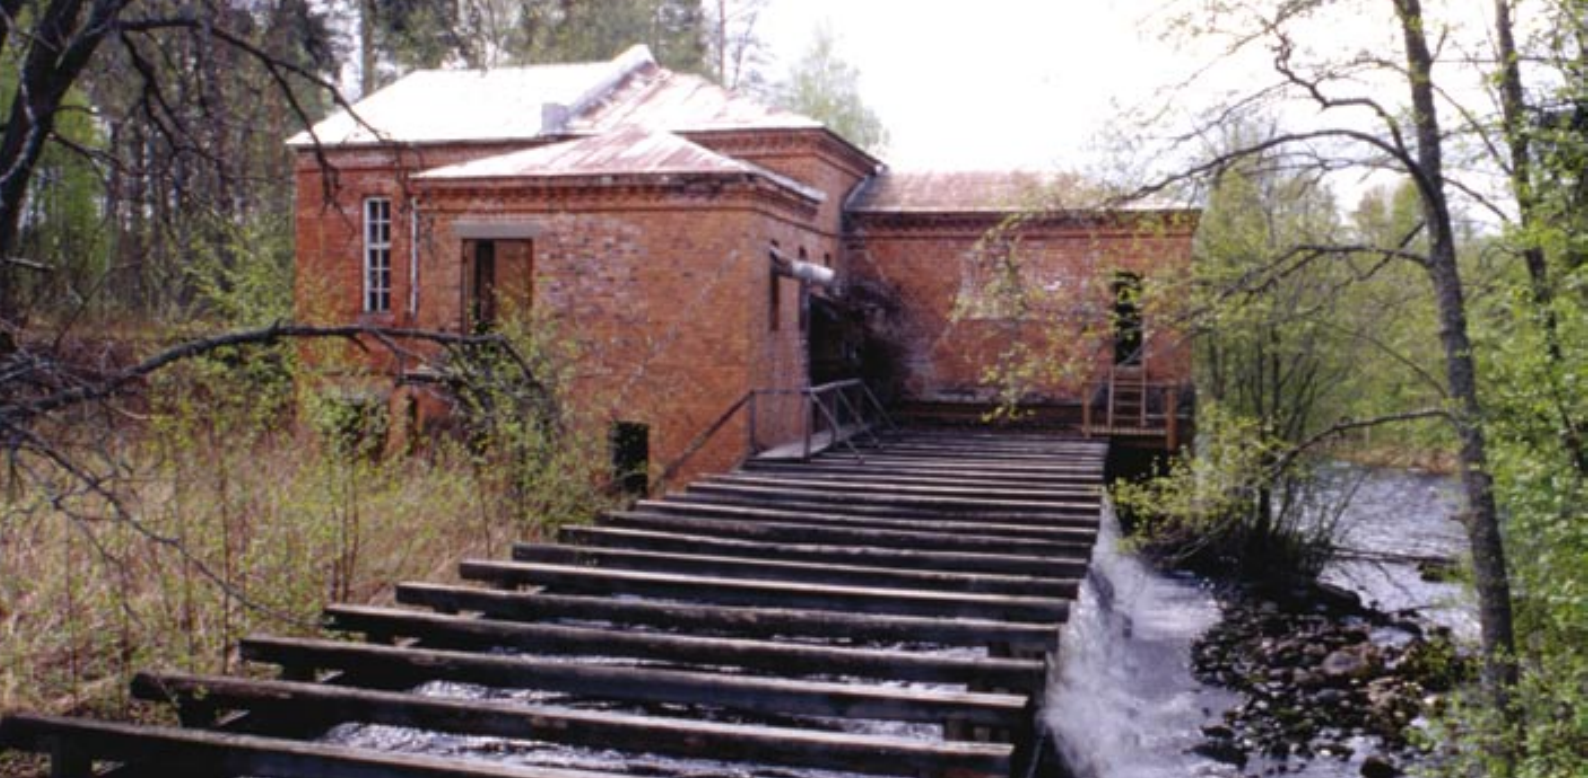
Illustration 30. The Lower Mill viewed from the north. In the centre, the flourmill wing and the power plant channel. Matti Huuhka 1998, Museokuva, MV.

The lower mill is a two-storey brick building, with lower wings on the western and northern flanks. It has a saddleback tin roof. Apart from the eastern gable, the roof is hipped. Part of the roof was replaced with corrugated iron, after a fire in the 1980s.<sup>90</sup> The windows are small-paned, narrow, and high, and sectioned into groups of three windows. The main entrance, with a pair of doors, is located at the eastern gable. There is a wide wooden bridge leading to the two-leafed door. The wooden power plant channel, leading to the turbines, lies at the northern flank of the mill.

The immediate surroundings of the building have gradually turned into a wetland, resembling a riverbed, and nowadays, the ground floor of the building resembles an empty basement. The river used to run further away from the mill, but it flows at present right alongside the building, which has turned the ground into a wetland.

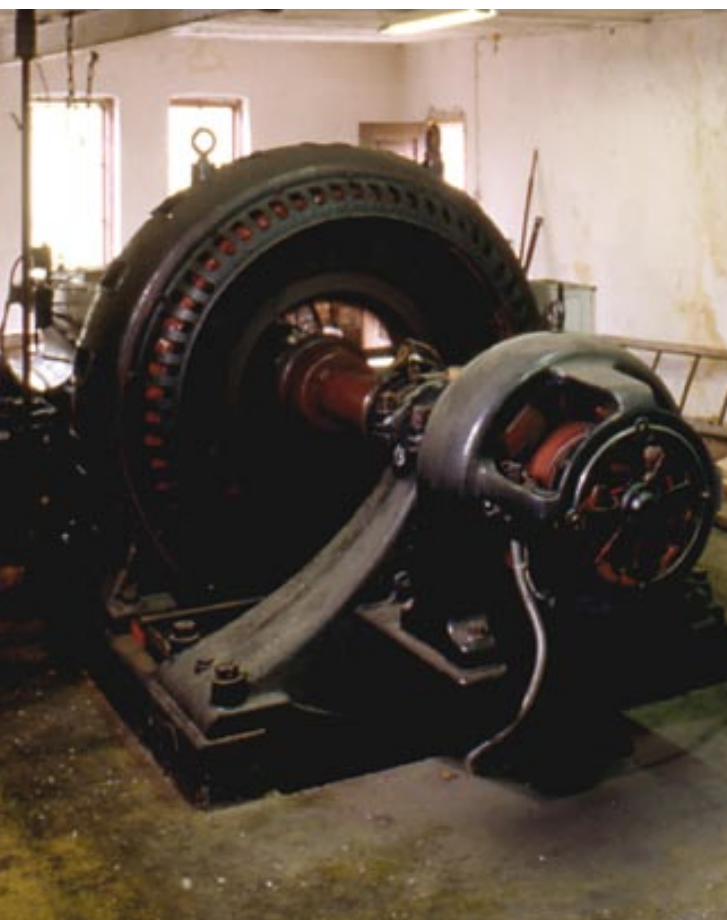
Illustration 31. The generator in the Lower Mill. Matti Huuhka 1998, Museokuva, MV.

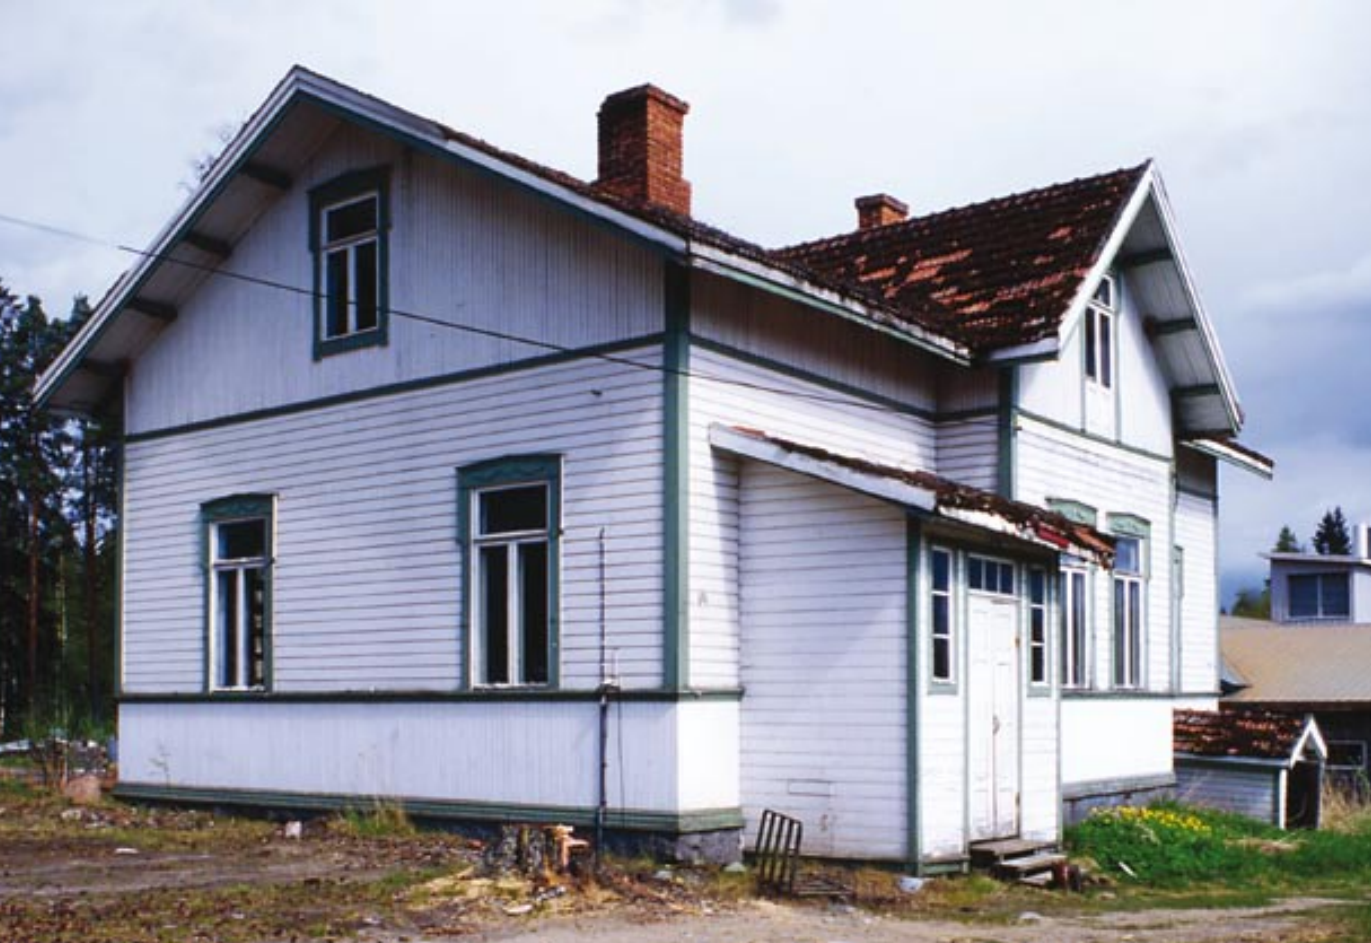
Illustration 33. The old office building viewed from the south-west. Matti Huuhka 1998, Museokuva, MV.

The old log-framed office building (A2) was completed in 1904.<sup>91</sup> Its measurements are 15.5 x 9.5 x 5.5 metres. At the time of this inventory, it had a red tile roof but in the summer of 2002, the tiles were replaced by a new tin roof. Underneath the eaves, there are moulded brackets.

The foundation is built of sturdy ashlars. There is a stone basement with a saddleback roofed timber staircase over the entrance.

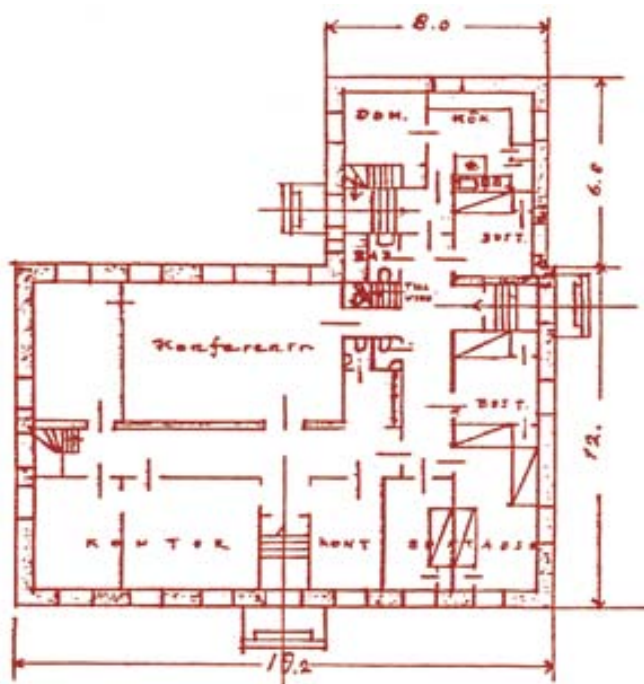
Illustration 40. Drawings for the new office building, 1937. Company archives.

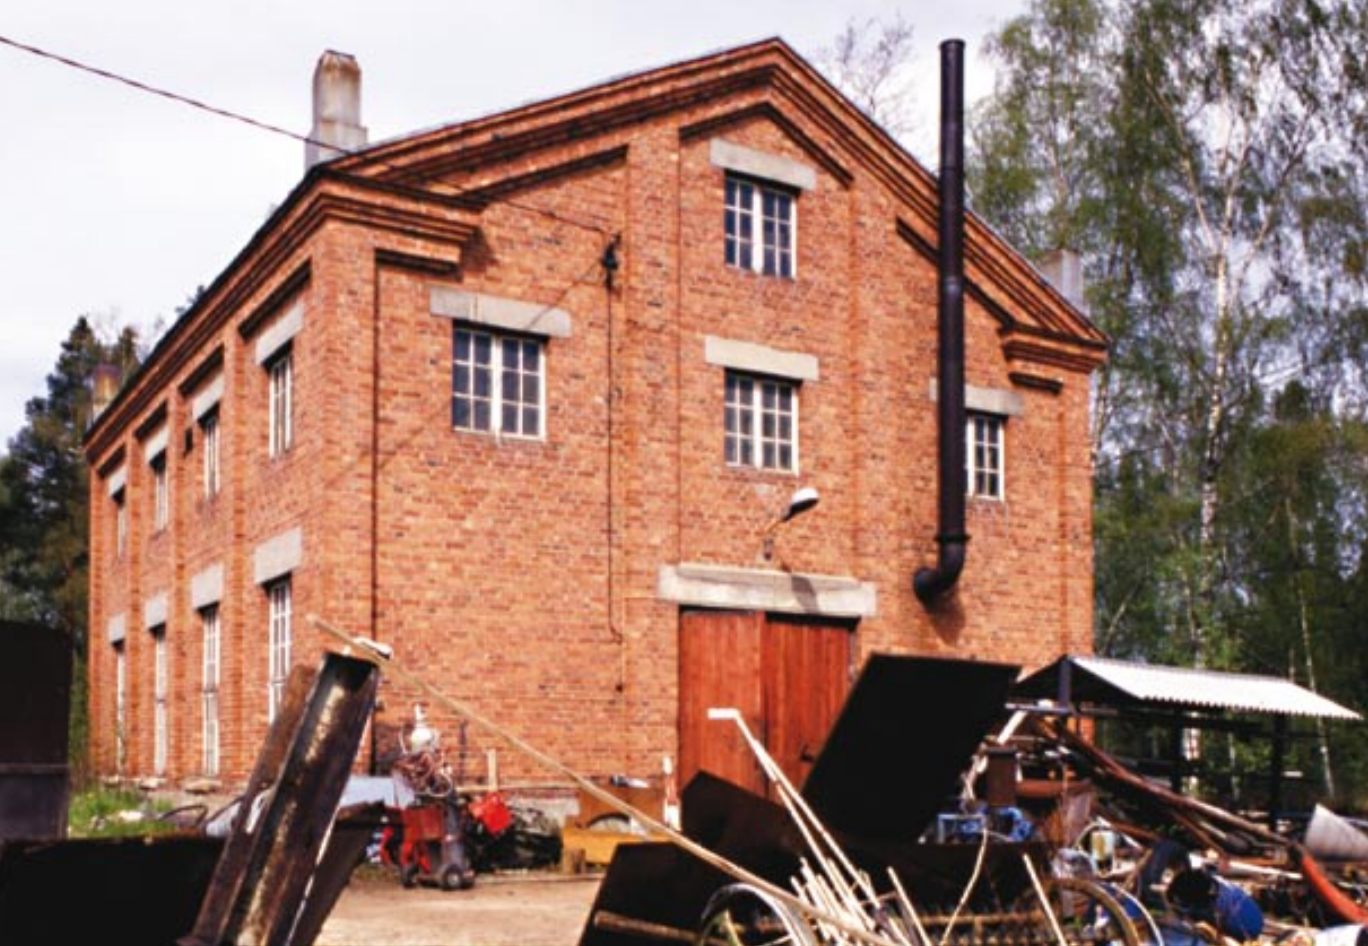
Illustration 41. The repair shop. Matti Huuhka 1998, Museokuva, MV.

The repair shop (T3) was built in 1924.<sup>96</sup> It is a two-storey brick building, which stands on a foundation of ashlars and has a saddleback tin roof. The dimensions are 15.5 x 14.9 x 7 metres. The building has massive eaves and four symmetrically sited tin-covered chimneys on the roof. The elevations are divided by vertical columns into sections.

The windows are small-paned, and the upstairs windows are lower than the downstairs ones. The riverside gable of the repair shop has a two-leafed door and a tin smoke flue, which passes through the wall at the site of the hearth. The flue is of later origin. The other gable has a two-leafed door, originally equipped with a ramp. There are white plastered lintels, made out of concrete, above the door and window openings.

The original appearance of the repair shop has been well preserved. The cardboard mill and the repair shop, which is about twenty years younger, have similar small-paned windows. The chimneys in the corners of the repair shop are special. The hearth has been preserved.
