# Vääräkoski Board Mill – One Hundred Years of Cardboard from Ähtäri

REPORTS OF WEST FINLAND REGIONAL  
ENVIRONMENT CENTRE 3 en | 2008

This inventory report is published as part of the renovation project of Vääräkoski Board Mill (Vääräkosken kartonkitehdas). The joint project of the West Finland Regional Environment Centre and the Regional Council of South Ostrobothnia, entitled "Renovation of Vääräkoski Board Mill", was initiated on June 20, 2000, and completed on February 29, 2008. The industrial and architectural review was carried out originally as a report in 2002 and revised in 2005.

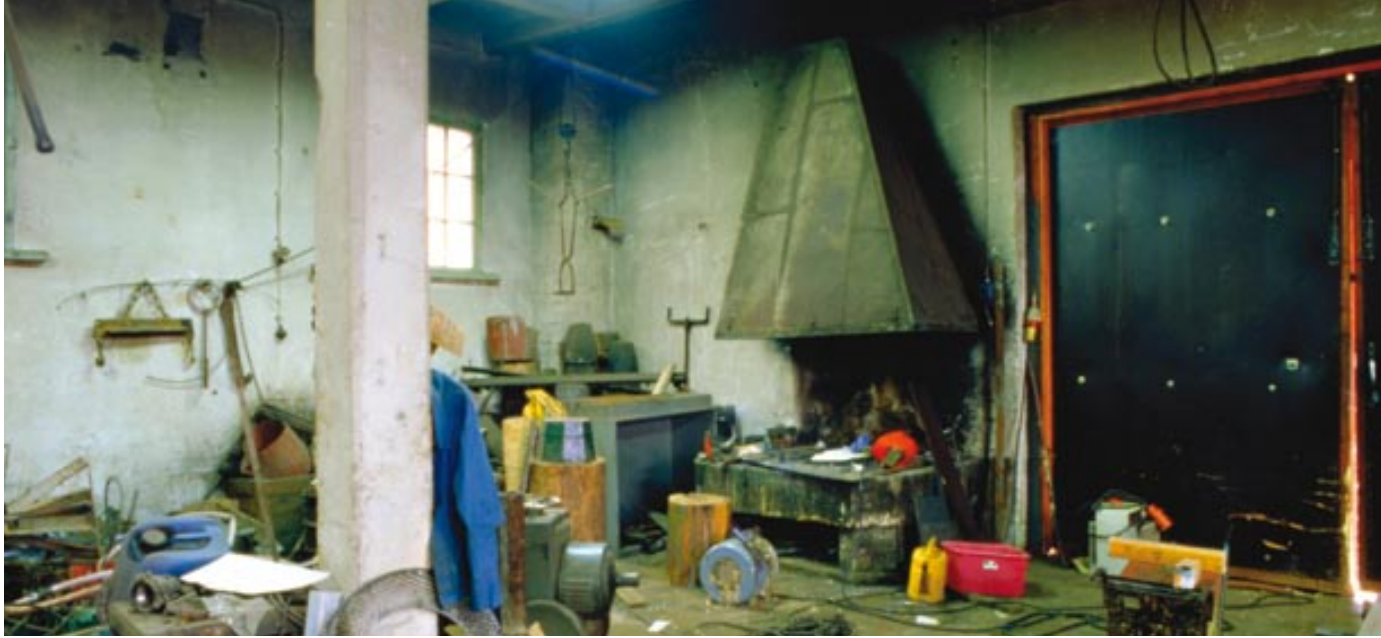
Illustration 42. The metal workshop. The hearth is in the background. Matti Huuhka 1998, Museokuva, MV.

The intermediate floor is made of reinforced concrete. The ceiling is divided by diagonal concrete beams into four identical zones, each of which has a round hole in the middle covered with a wooden lid. These holes are connected to the original heating system. There used to be spherical copper containers by the holes. The purpose was to burn straw in the containers, but apparently, the system was never used. The repairman, who provided this piece of information, remembers, however, that the containers were still connected to the shop ceiling in the 1950s.<sup>97</sup>

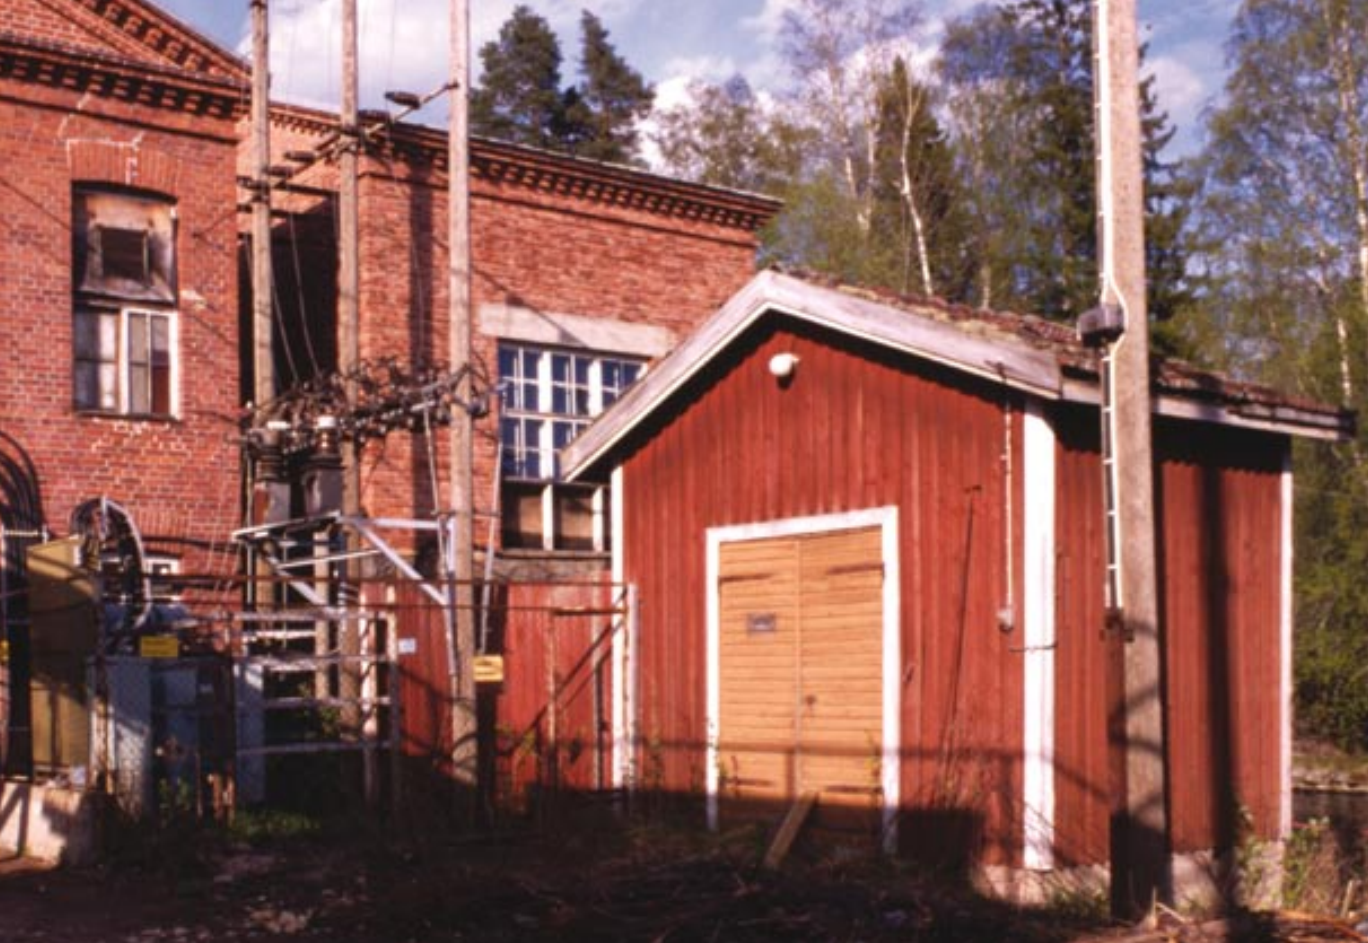
Illustration 44. On the right, the transformer house standing alongside the board mill. Matti Huuhka 1998, Museokuva, MV.

By the side of the cardboard mill, stands a transformer house (T6) built in 1940. It is a fairly small timber building on a concrete foundation. The red

transformer building has vertical boarding and a saddleback roof with red tiles. There is a two-leafed door with horizontal panelling at the end of the building.

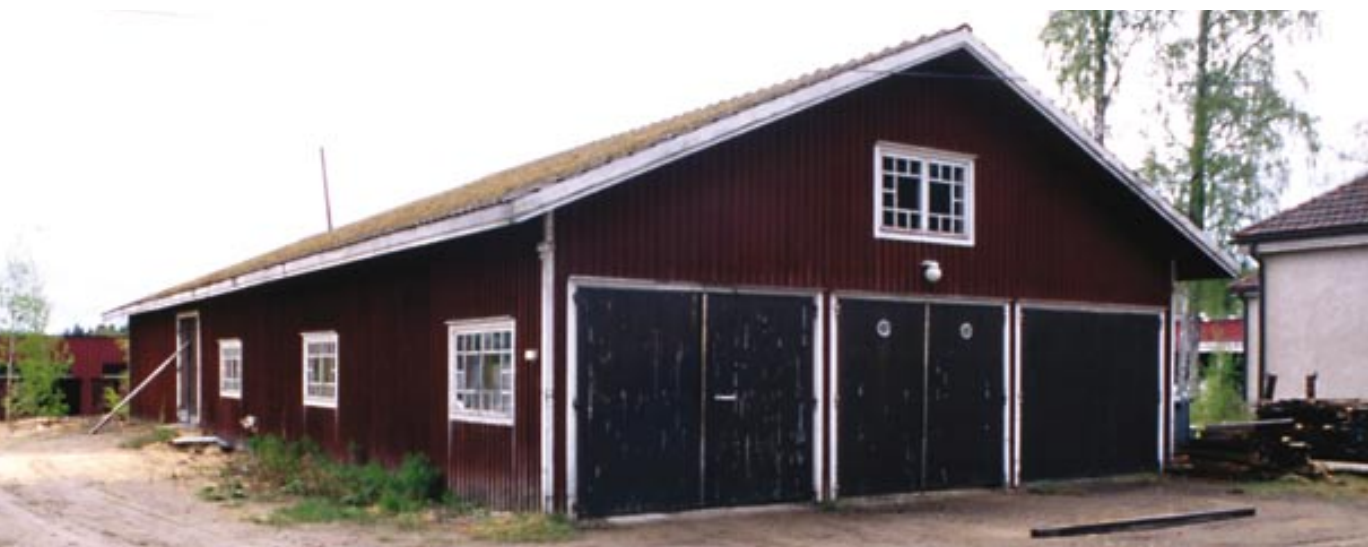
Illustration 45. The garage/stable. Matti Huuhka 1998, Museokuva, MV.

A garage (U2), built in 1914, stands between the old and new office buildings. It was originally a stable. The mill had as many as six horses for transportation purposes. In the early days, horses either pulled the logs close to the rafting flute or straight to the mill. Trucks took over the transportations in the early 1930s. As trucks became more and more commonplace, horses were no longer required for this task. The mill bought its own truck after the war. At one time, there were two trucks. The mill dispensed with its own trucks in the 1970s, whereupon the garage was used as a shelter for passenger cars. The south gable houses a hall-like workshop that was used for production since the 1980s. From time to time, a rolling-up machine was used in this workshop. It is the old rolling-up machine from the Kyröskoski mill, and brought to Vääräkoski in the 1980s. Premises required by the pallet workshop, were later added to the gable of the garage.<sup>101</sup> The oldest part of the garage was built with logs; however the more recent parts are timber. The foundation is of ashlar. The garage has a vertical board lining, and its saddleback roof is covered with burnt brick tiles. It has small-paned windows. Apparently, the garage end was built later.

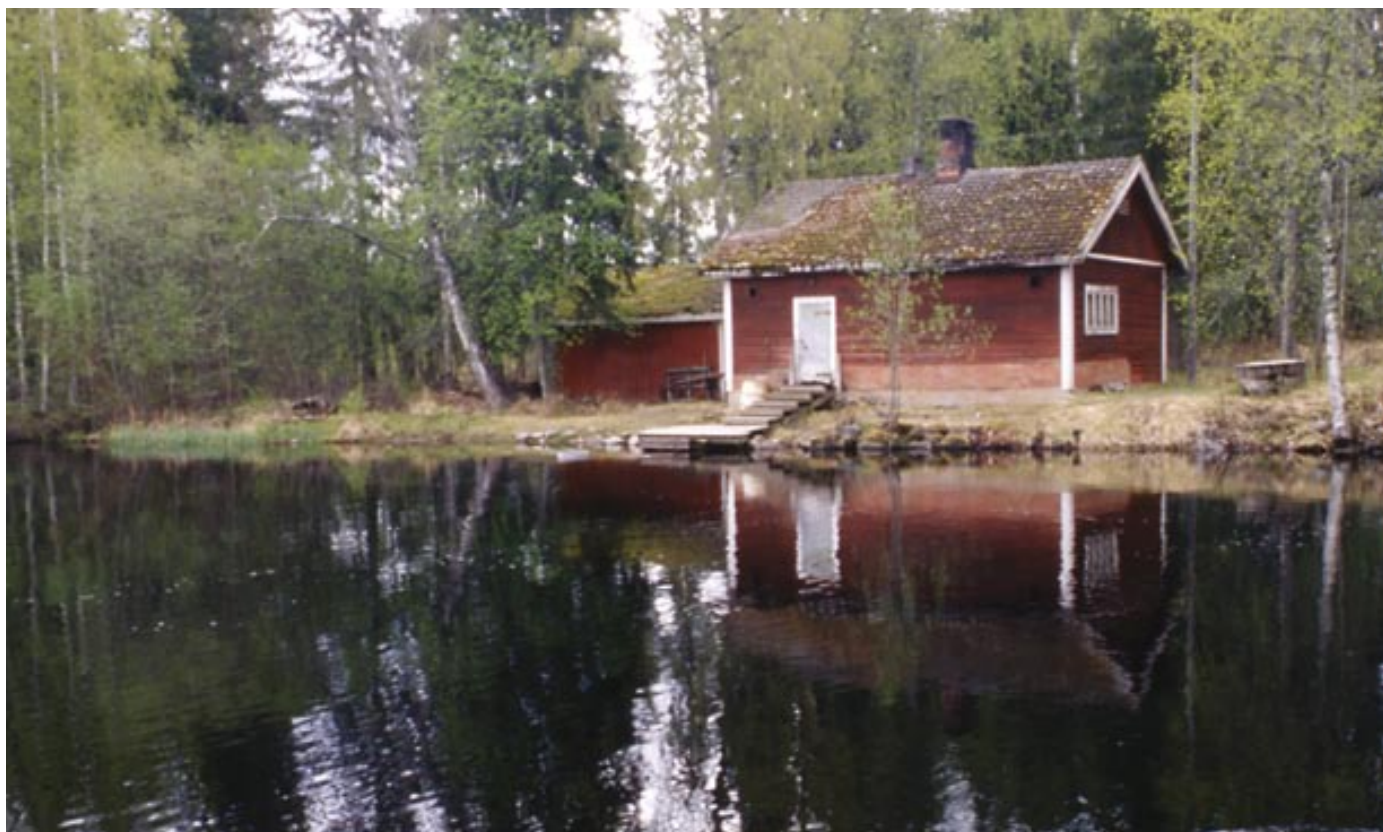
Illustration 46. The sauna. Matti Huuhka 1998, Museokuva, MV.

The mill sauna (U5) is located across the river, about 50 metres from the mill. It is a red log building built in the 1930s. It rests on a concrete founda-

tion and has a saddleback roof covered with concrete tiles. The exterior is horizontal rebate-joint boarding. The sauna-end foundation has been renovated later by the replacement of the lowest tiers of logs, which had rotted, with a higher concrete foundation. The windows are six-light, except in the sauna-end, which has a three-light window. There are two entrance doors to the building. On the riverside, the door leads to a washhouse, which has e.g. two large water cauldrons and a pipe leading to the sauna. The door to the sauna and the dressing room is on the yard-side. The previous old sauna building was located close to the director's residence.

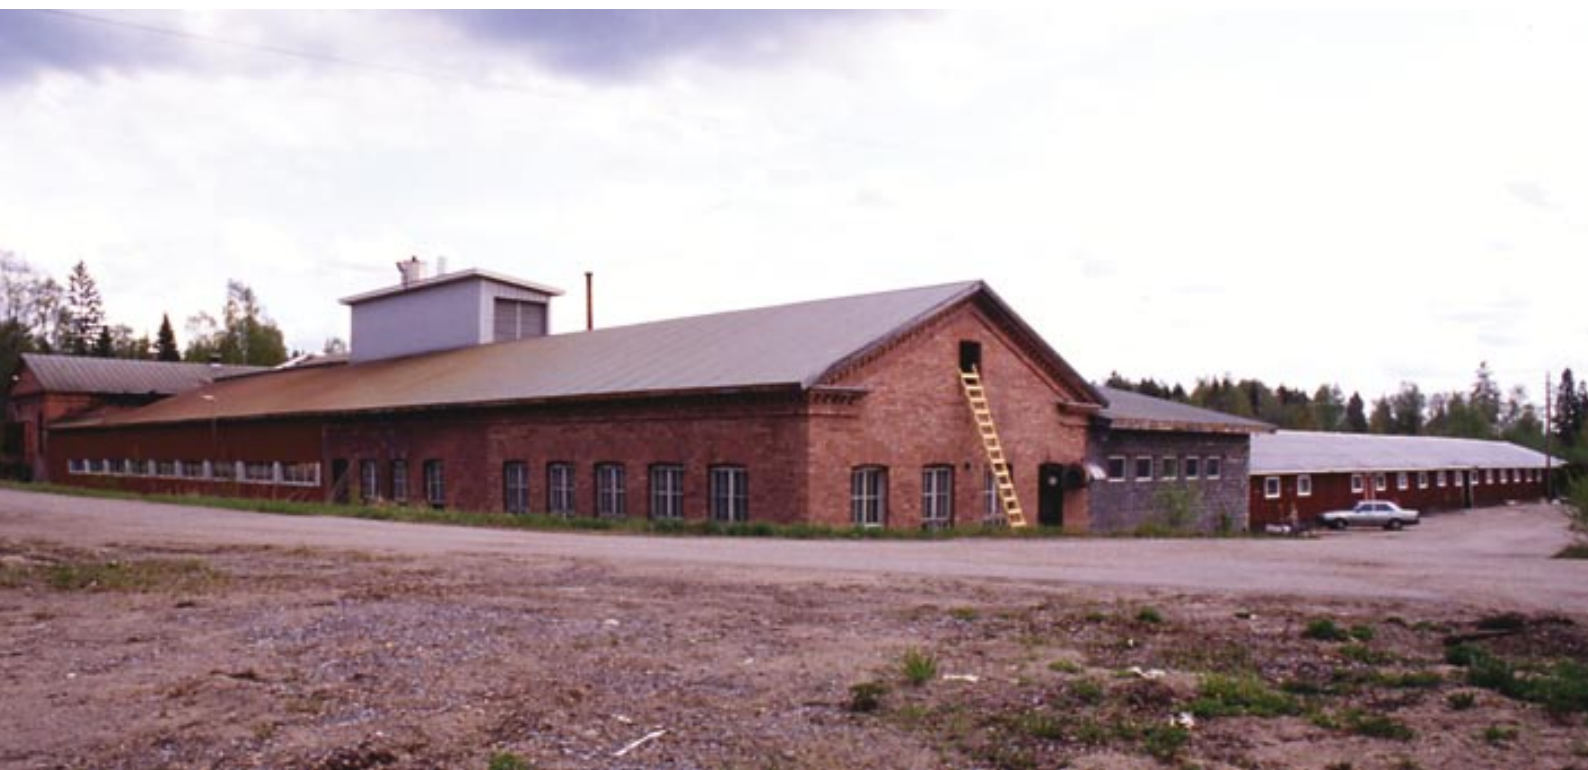
Illustration 47. The cardboard mill. Matti Huuhka 1998, Museokuva, MV.

The exterior of the cardboard mill building has been preserved, for the most part, in its original format. The cardboard mill denotes a building complex including the cardboard mill, the groundwood pulp mill, and the power plant (now the powerhouse). It is not known who planned the construction but, by all accounts, it must have been one of the industrial architects of that time. The repairs and renovations carried out in the 1980s and 1990s altered the exterior. The modifications were

carried out at an economically bad time for the mill and, consequently, they were performed as cheap as possible. The new additions are mainly seen on the south elevation, where a pulper hall and a bark-burning plant were built. The flèche, standing on the groundwood pulp mill, was pulled down, and some of the windows have been altered. More than half of the north wall of the cardboard hall has been totally renewed.

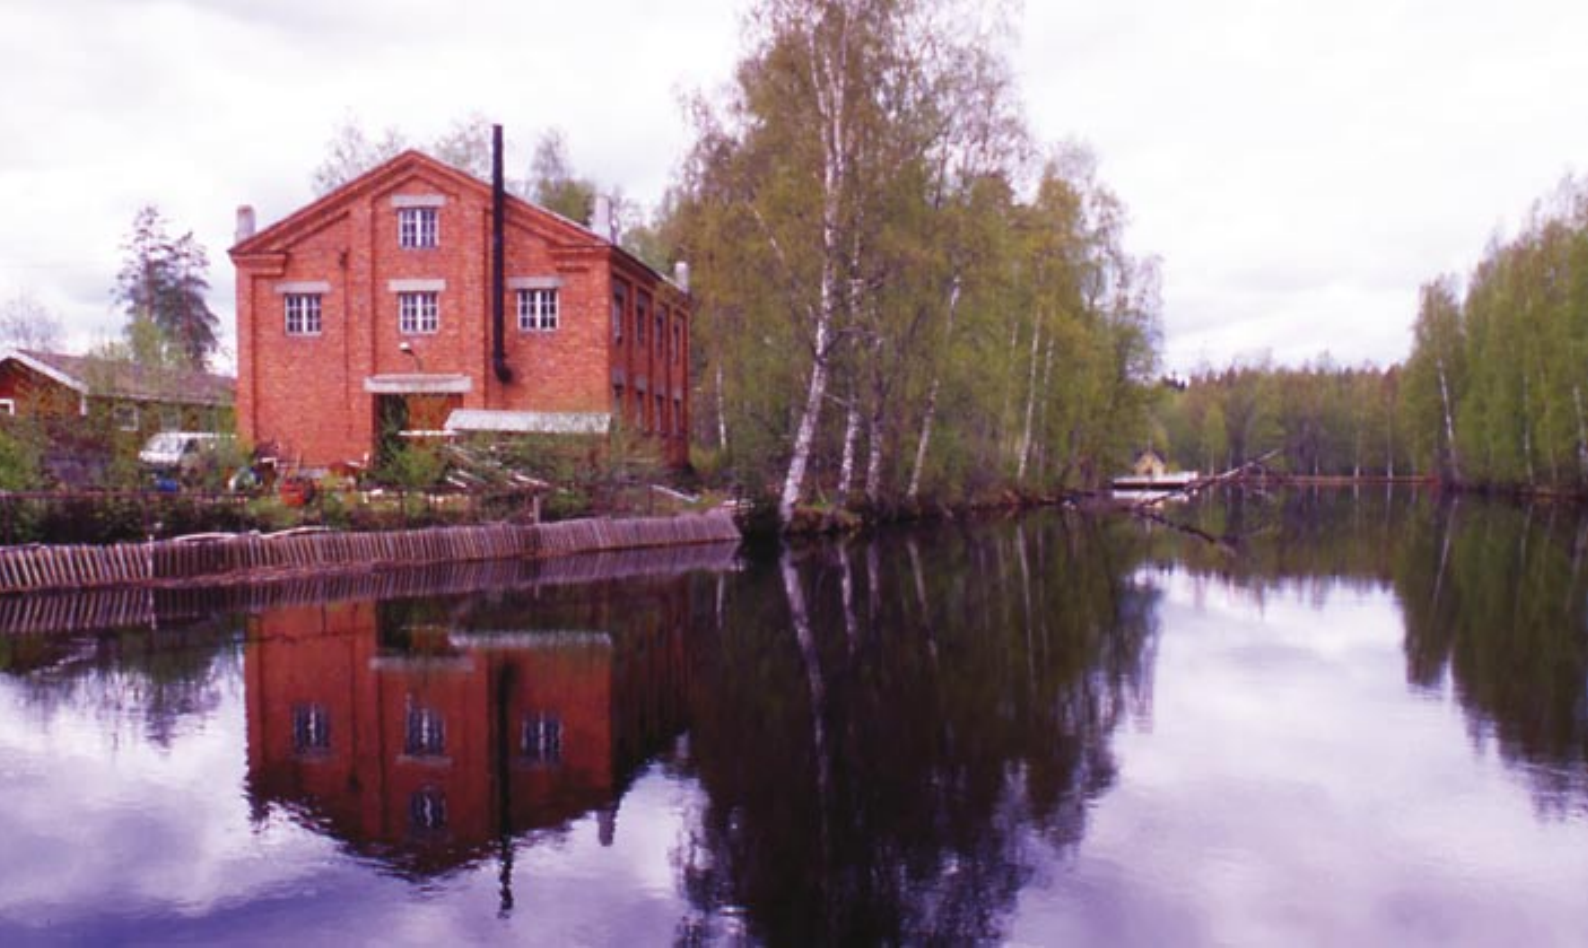
Illustration 48. The repair shop. Matti Huuhka 1998, Museokuva, MV.

The structures of the repair shop, built in 1922, by the river, have been better preserved than those of the cardboard mill. Downstairs, there is a hall-
